# Manhole Inspection Summary

Manhole # S11MM\_036MH

Insp Date: **1/21/09 11:22 AM**

**Location** Address: **2227 LONGWOOD ST**

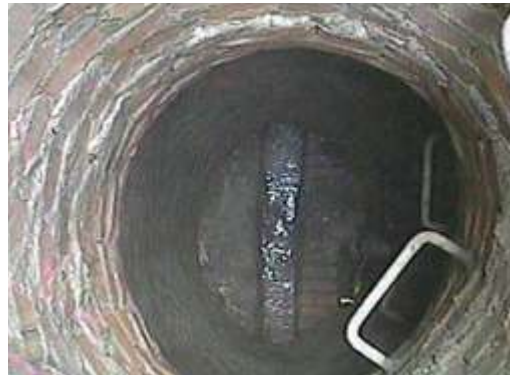
Top View

DEBRIS ON BENCH AND IN CHANNEL.

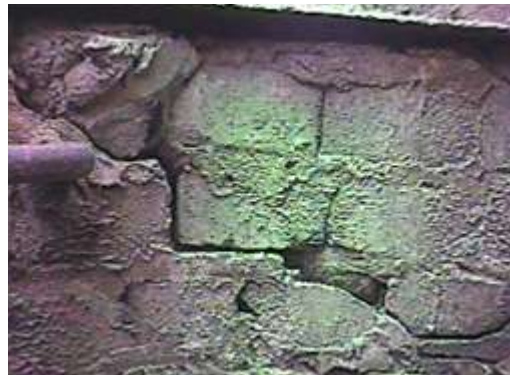
Defect 1

Condition: ☐ Sound ☒ **Cracked** ☐ Root Intrusion ☐ Loose Brick ☐ Deteriorated

CRACKED CORBEL

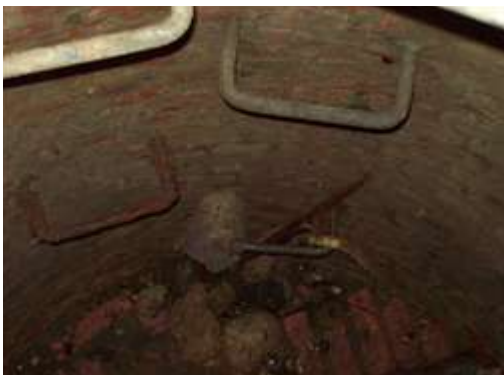
Defect 3

**Surcharge** ☒ **Evidence Of Surcharge** Depth: **3** (ft.) ☐ Active Surcharge Present

EVIDENCE SURCHARGE

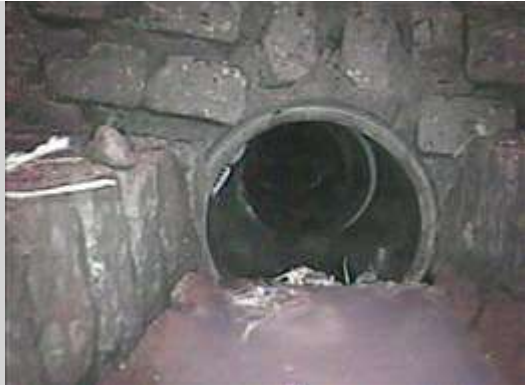
12 O'Clock Outflow

DEBRIS ON BENCH AND IN CHANNEL.

Pipe Height: (in.) Direct  
Pipe Material: **Clay** ☐ Pipe Lined  
Invert Depth: **11.69** (ft.) Flow Characteristics: **Slow**  
Deposits: ☐ None ☐ Mud ☐ Sludge ☒ **Debris** ☐ Grease  
Silt Depth: **2** (in.) Deposits Extent: **Medium**  
Infiltration: **None** Pipe Seal Cond: **Sound**

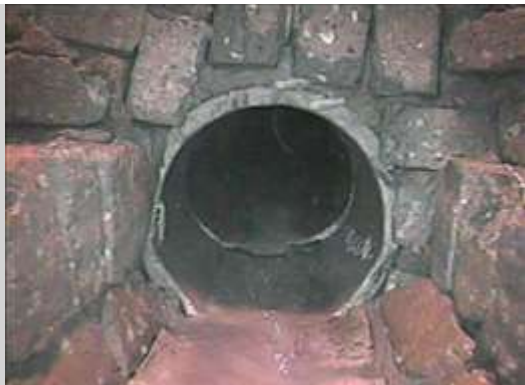
6 O'Clock Inflow

Pipe Height: (in.) Direct  
Pipe Material: **Clay** ☐ Pipe Lined  
Invert Depth: **11.65** (ft.) Flow Characteristics: **Slow**  
Deposits: ☒ **None** ☐ Mud ☐ Sludge ☐ Debris ☐ Grease  
Silt Depth: (in.) Deposits Extent:  
Infiltration: **None** Pipe Seal Cond: **Sound**
